CR-184104

Flight Motor Set 360T010 (STS-31R) Final Report

Volume I—System Overview October 1990

Thiokol CORPORATION
SPACE OPERATIONS

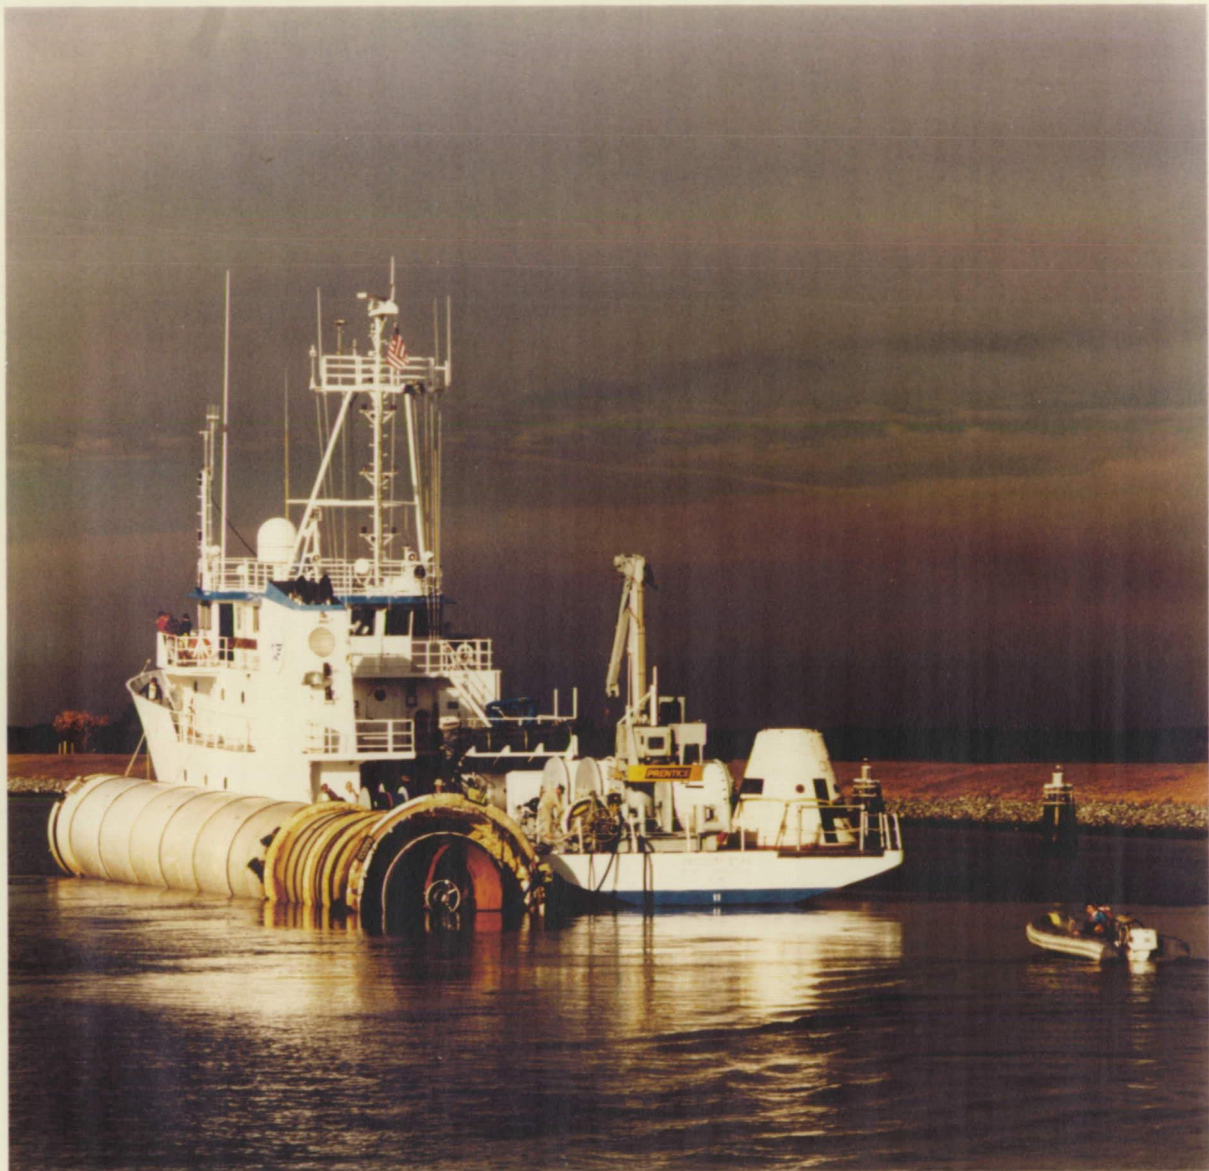
The left redesigned solid rocket motor from flight set 360T010 is towed to Hangar AF for disassembly and evaluation. The motor set performed flawlessly as part of STS-31R, launched 24 April 1990 at Kennedy Space Center, Florida.

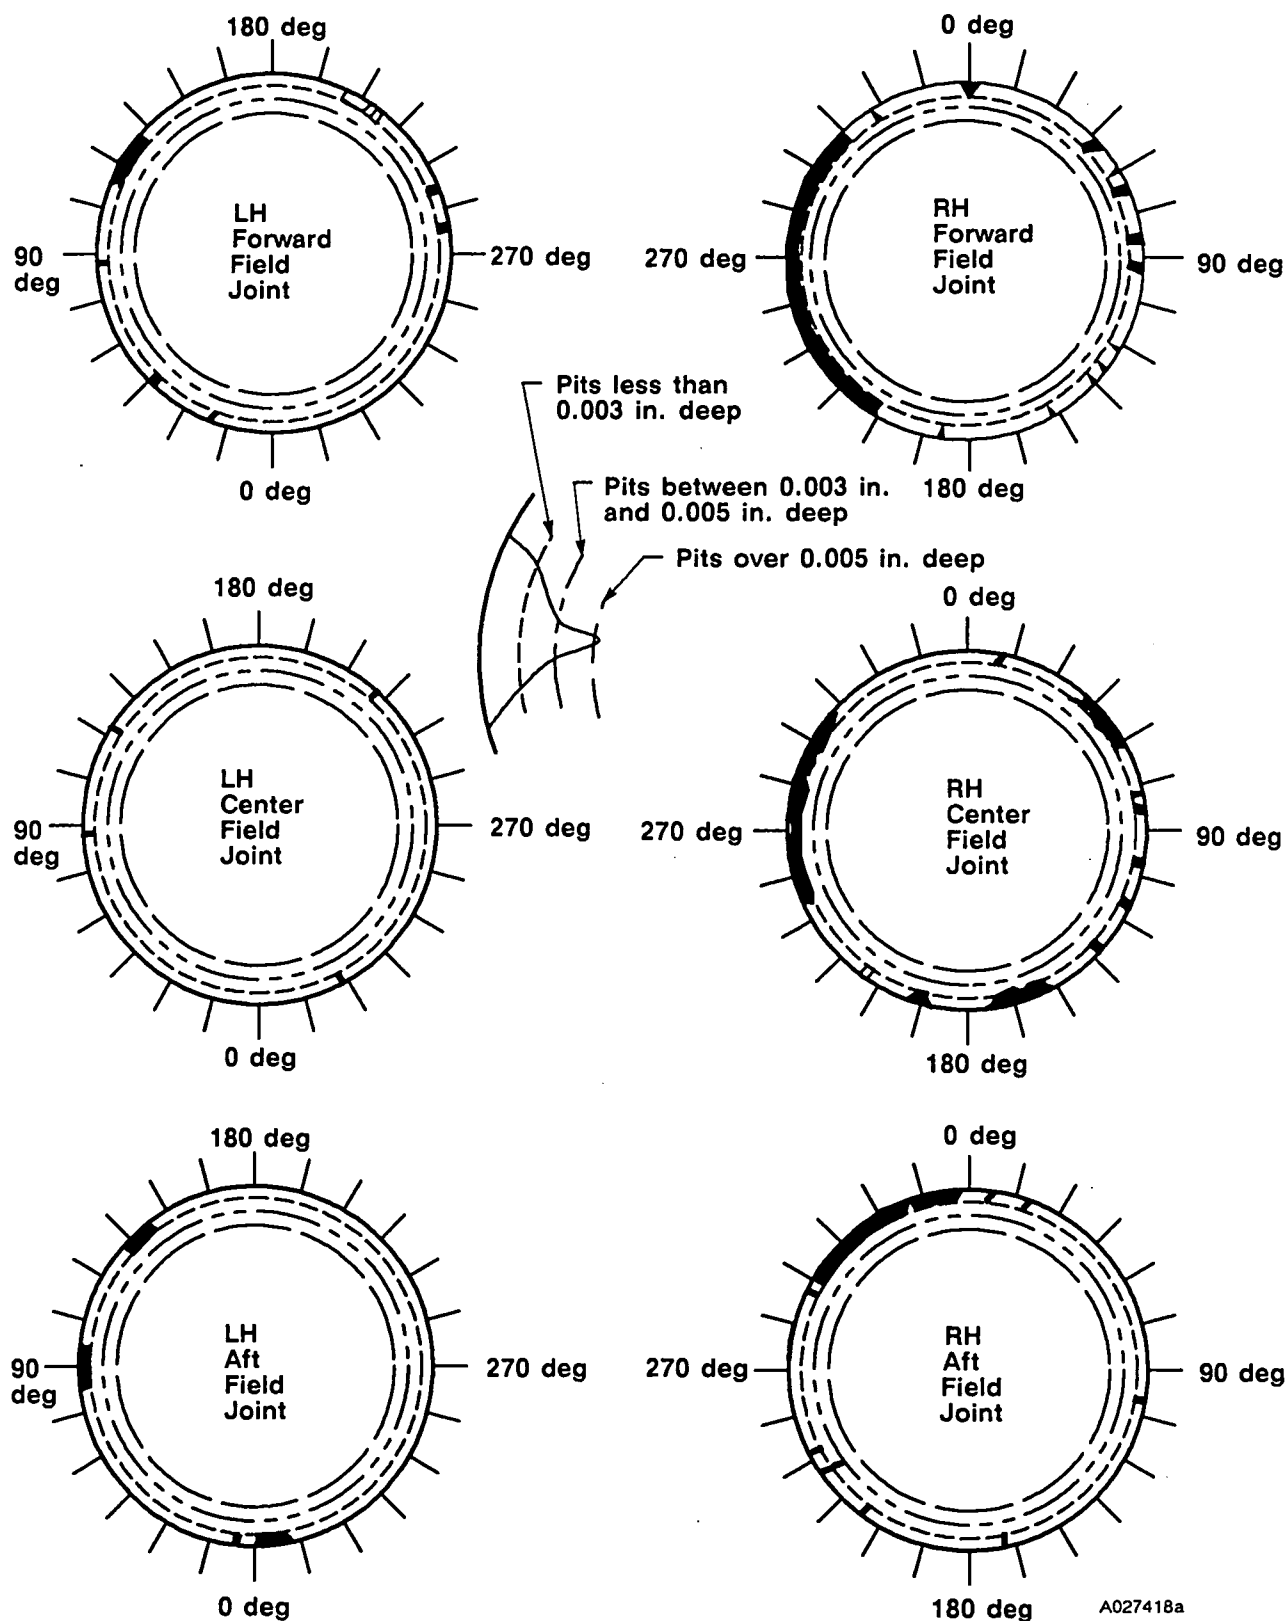
Figure 4.11-1. Field Joint Fretting-360T010

3.1.9.2 Case. The case field joint surface conditions were as expected. Field joint fretting on this flight ranged from light to medium. All joints had some fretting. The RH aft field joint had the worst fretting with one pit 0.005 in. deep. The RH forward, center, and aft field joints had previously fretted segments. There were no new frets found in the old fret indications. Light corrosion was noted on the LH and RH forward dome boss along the outer edge chamfer the full circumference.

On the LH motor case, pits measuring 0.005 and 0.007 in. were observed. On the RH motor, pits measuring 0.005, 0.007, and 0.012 in. were observed. Some of the case surfaces under the removed GEI runs had light corrosion.
